# BELZONA REPAIRS AND PROTECTS MULTIPLE BALCONIES ON LARGE HOUSING SITE

A large housing estate in Leicester with 7 x multi-storey blocks of flats with balconies

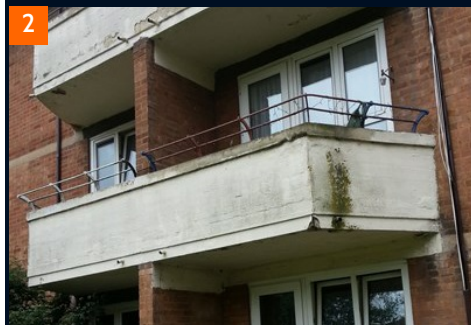
The existing coating on all the concrete balconies was flaking off and in many areas the concrete was broken and cracked where moisture has rusted the steel reinforcing bars inside the concrete structure. The concrete base of the balconies was a slip hazard when wet.

- 1.The block of Flats
2. Damaged Balconies
- 3.Typical problem on a balcony with current coating coming off and damaged concrete exposed
- 4.Balconies after the Belzona repairs and coating has been completed

Application was carried out in accordance with a modified version of Belzona System Leaflet FPA-1 and FPA-8. All broken and damaged areas of concrete were repaired with Belzona 4141. The balcony walls and underneath surfaces were coated with Belzona 5151. A non-slip surface was created on the balcony floors with Belzona 5811 blinded out with aggregate.
