# BELZONA 1812 EXTENDS LIFE OF SCREW CONVEYOR

ID: 7541

A large screw conveyor transporting wood chippings to the top of a CHP furnace. The constant feed of chippings is critical to the plant's operation.

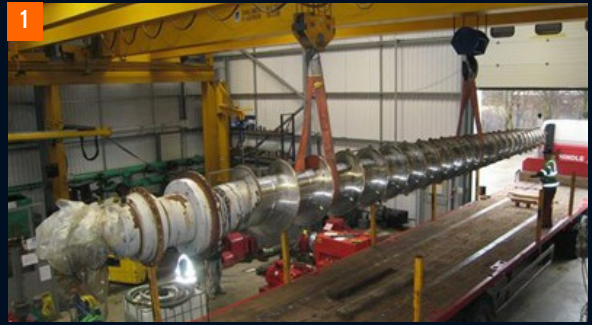
1. Delivery of the screw
2. Belzona 1812 applied to the shaft & the 'driving' face of the flights
3. Close up of Belzona 1812 finish
4. Completed application.
