# BELZONA TANK BASE SEAL STILL GIVING SUPERB PROTECTION

ID: 7544

Carbon Steel Fuel Storage Tank

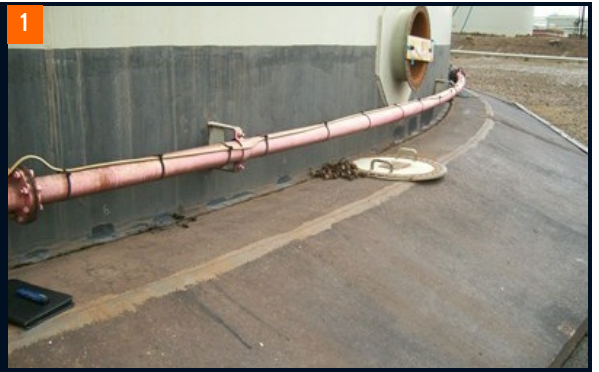
Over the years the bitumen and sand base under this 36m diameter tank had compressed, to such an extent that the annular rim was now at least 10mm below the surrounding concrete plinth. Water was actually being captured at the rim which had dramatically increased the risk of under base corrosion. Various mastics had been tried in the past, but all failed quickly.

1. Initial condition of tank.
2. Annular rim creating channel for water.
3. Tank Base Seal application in 2010.
4. Tank revisited in 2017

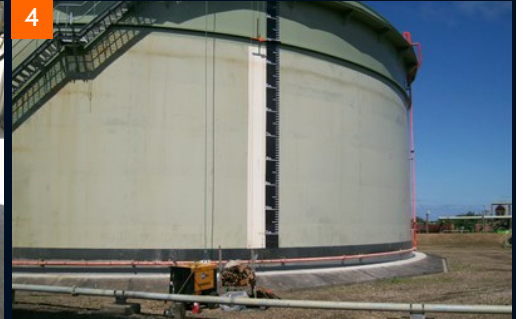
For many years this customer had recognised the long-term benefits of using the Belzona Tank Base Sealing system. After reprofiling the plinth, the Belzona Tank Base Seal was installed around the full diameter, preventing any risk of water ingress to the base. The work was inspected again in 2017 and is still in perfect condition. To date this client has protected over 50 tanks with the Belzona Tank Base Seal solution.
