# BELZONA REPAIRS CORRODED LIME TANK

ID: 7545

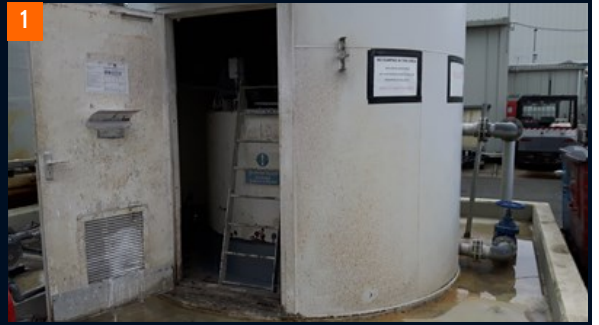
Customer had a 25 year old lime holding tank

- 1) Lime Tank Structure
- 2) Corroded area detail
- 3) Corroded area around the inner tank
- 4) Finished application

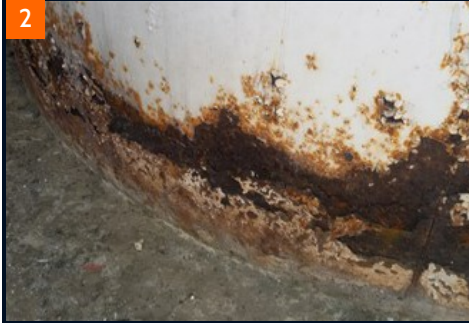
The tank was suffering from corrosion problems around the outer lower sections of the tank. In addition to this, there was also corrosion to the base of the smaller inner tank.

Application was carried out in accordance with a modified version of Belzona System Leaflet TCC-5. Corrosion along the base was removed via grit blasting then plates were bonded in place to reinforce the steel work. Belzona 5811 was then applied to protect against further corrosion.
