# LIVE LEAK REPAIR TO 8" SLUDGE PIT DISCHARGE PIPE WITH BELZONA

ID: 7546

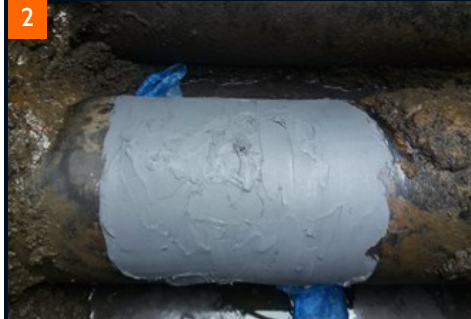
Customer had a major leak on one of their main sludge pit discharge pipes which was buried 1 metre below ground.

1. Leaking pipe.
2. Pipe wetted out with Belzona 1161.
3. Bond plate wetted out.
4. Bond plate in position.

Application was carried out in accordance with Belzona System Leaflet VPF-11. The pipework was prepared using hand tools and degreased with Belzona 9111. The leak was plugged using Belzona 9611. Both pipe and bonding plates where wetted out using Belzona 1161, bonded together and held in position with straps then left to cure.
