# BELZONA SAVES UNIVERSITY LIBRARY FROM WATER INGRESS

ID: 7547

Library at a Manchester University

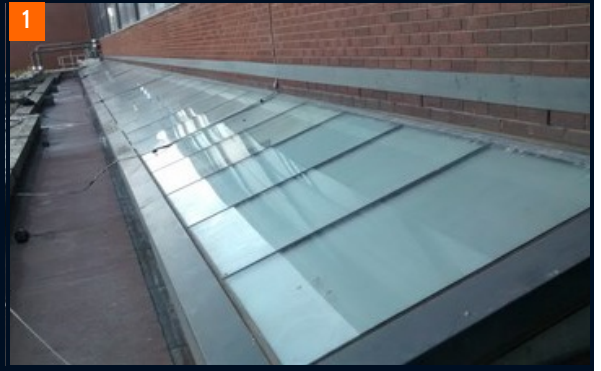
Long stretch of roof lights over library allowing natural light into the building

1. Overview of the units
2. Close up of the damaged area
3. Internal view
4. Completed application with Belzona 3121 in place

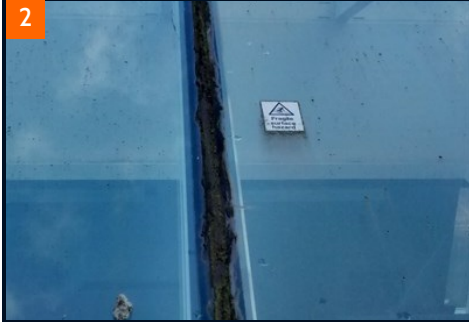
Water ingress was discovered resulting from failure of the sealing materials between the glazed units, caused by UV attack and constant movement due to thermal expansion.
