# BELZONA ENSURES SAFETY AT A UNIVERSITY

ID: 7549

Steel fire escape from first floor at rear of building.

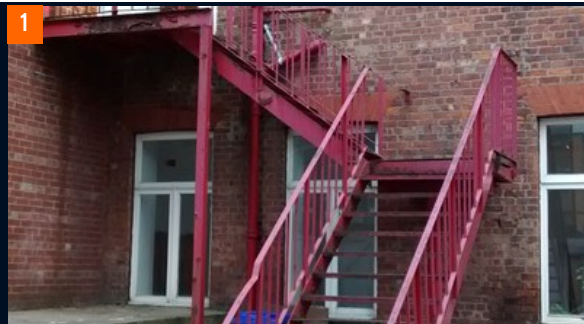
During a fire drill it was discovered that the steel chequer floor was slippery. This presented a real danger particularly in a real emergency. Left unresolved there could have been disastrous consequences.

1. Overview of the fire escape before application
2. Close up of the steel chequer plate
3. Close up of completed application
4. Overview of completed application
