# ROOF OF AN ART DECO BUILDING SAVED WITH BELZONA

ID: 7550

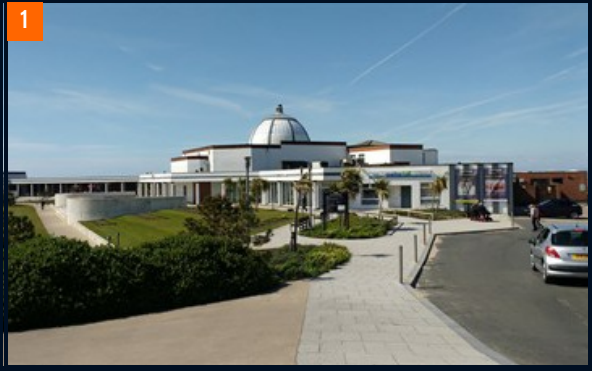
1. Overview of the building
2. One small section of the roof before
3. The same small section after application of Belzona 3111
4. Belzona 3111 coated section close to the dome area

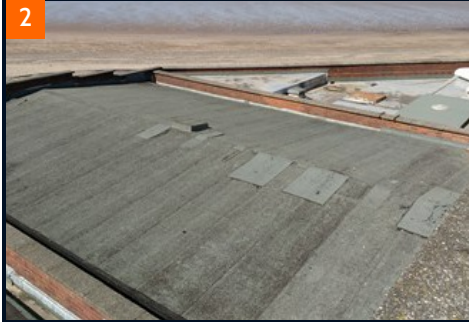
The roof is a large expanse with several separate roof areas on different levels. There were numerous leak areas through the existing roofing felt that required repair to prevent permanent damage to the wonderful interior which is still used for numerous events on a regular basis including ball room dancing.
