# BELZONA SOLVES CORROSION ISSUE ON SHEET EDGE ROOFING SECTIONS

Large metal roof covering local leisure center.

Leisure Center, Fleetwood, England, UK

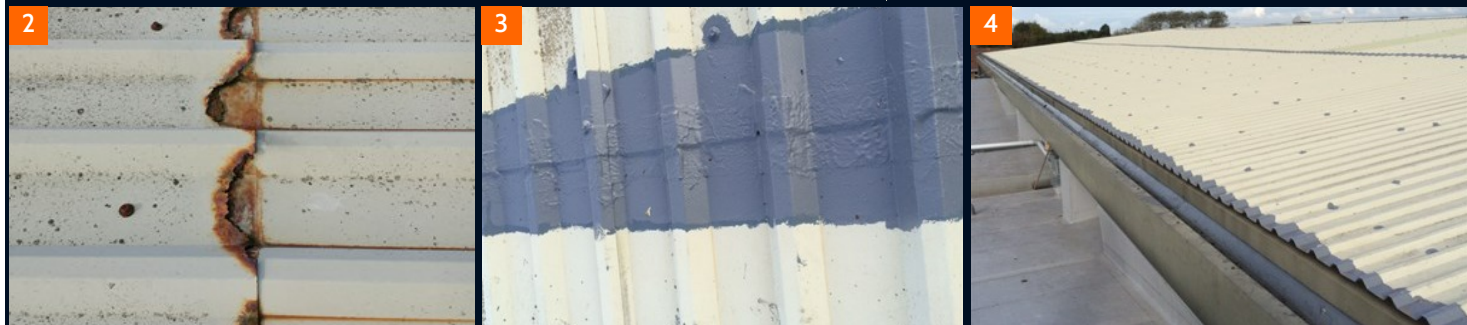
The area is close to the coast making corrosion of metal a real problem on exposed areas of mild steel. This large metal roof was suffering significant sheet edge corrosion damage.

1. Overview of roof area affected by sheet edge corrosion
2. Close of of a badly damaged area
3. Close up of a repaired area
4. Overview of repaired roof area

The application was carried out in accordance with Belzona Know-How System Leaflet RPA-1.

Belzona 3131 (WG Membrane)
