# BELZONA REPAIRS POROUS GEARBOX

ID: 7552

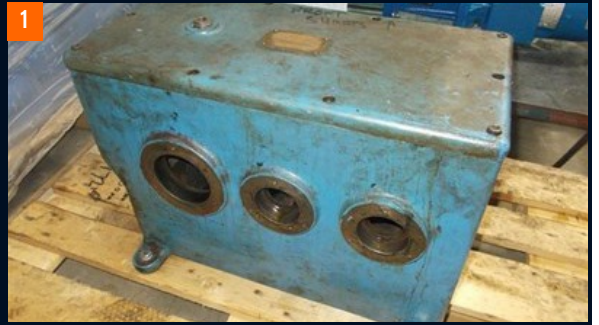
The gearbox was found to be porous and was leaking oil. This loss of oil was hampering the proper operation of the gearbox. The exact areas which were porous would be difficult to identify. The only sure way of sealing the internals was by coating with an impermeable barrier.

1. Gearbox disassembled
2. Grit blasting complete
3. Lid of gearbox coated
4. Body of gearbox coated

Application was carried out in accordance with a modified version of Belzona Know-How System Leaflet ENC-1. The gearbox was first grit blasted, then a two coat system of Belzona 5892 was applied to the internal areas.
