# BELZONA REPAIRS PITTED ENGINE CYLINDERS

ID: 7553

An engine block for a tugboat was found to have pitting around the cylinders.

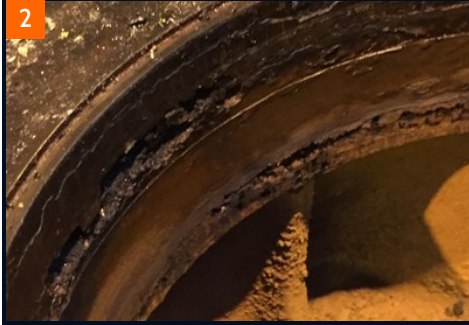
1. The Engine block
2. Close up of pitting damage
3. Areas after grit blasting
4. Application of Belzona 1111

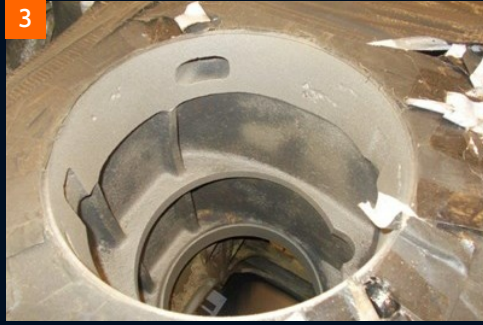
Weld repairs would be problematic & time consuming on this area. They would also not solve the original issue of corrosion.
