# BELZONA PROTECTS FLANGES FOR GAS WORKS

ID: 7554

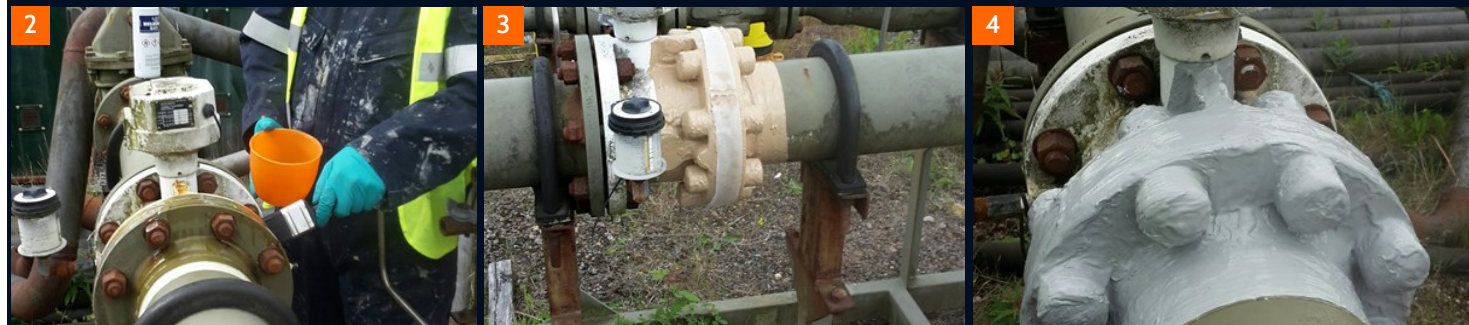
## PHOTOS

1. Flange with void taped
2. First coat during application
3. First coat applied
4. Second coat applied

A section of pipework had an exposed flange that was deemed to be susceptible to corrosion.

Application was carried out in accordance with Belzona Know-How System Leaflet GSS-11.

The Belzona solution allows the flange to be protected and then accessed when required for maintenance or inspection. Traditional painting of the flange would leave it inaccessible and may not completely encasulate the flange potentially allowing corrosion to still occur.
