# BELZONA SAVES A CEMENT SILO LID

ID: 7555

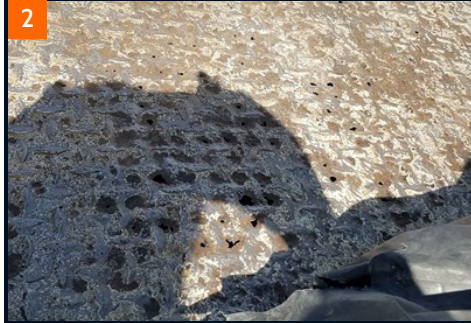
Any moisture ingress will ruin the stored materials. The customer had noticed problems and after inspecting found that the lid was severely corroded and was letting in rainwater. The silo is 11 metres high, to replace the lid would be logistically very difficult and incredibly expensive.

1. The silo lid at the start of the repairs
2. A closer look at the damage
3. The lid repaired with Belzona 1111 plate bonding techniques
4. The finished lid after application of Belzona 5811

Application was carried out in accordance with Belzona System Leaflets TCC-1 and TCC-5. Steel plates were bonded to the lid using B1111 where required to repair the holed areas before applying two coats of Belzona 5811 to provide overall corrosion protection.
