# BELZONA PROTECTS THE SURFACE OF MAIN WATER-PUMP INLET MANIFOLD

ID: 7556

Corrosion on a 50 year old inlet manifold at the bottom of an 80 metre deep column in an Ilmenite factory.

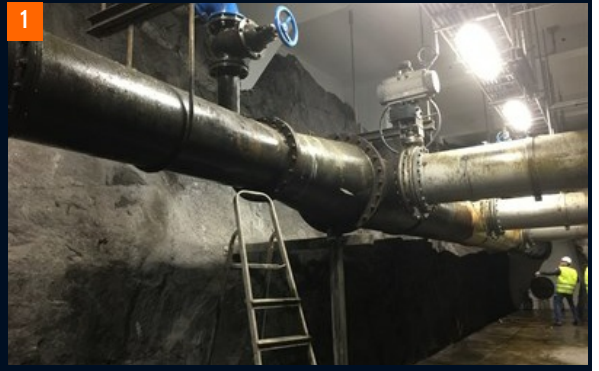
Severe corrosion on these pipes externals had developed over 50 years, several unsuccessful attempts to protect the pipe had been started and ended without fully protecting the surface over the last 10 years. Humidity of 100%, constant running water from the surface and no possibility to gritblast meant conditions were not ideal for a coating application.

1. Overview of wet and condensed pipe manifold.
2. Surface preparation and first coat application ongoing.
3. First coat applied.
4. Final coat applied and cured. Constant running water from the surface can be seen.

Application was carried out in accordance with a modified version of Belzona Know-How System Leaflet CEP-4. Manual surface preparation was carried out using a combination of different tools. Belzona 1212 was used to fill deep pitting in the surface. Then, Belzona 5831 was applied for corrosion protection.
