# BELZONA STOPS A LIVE LEAK ON SEAWATER MANIFOLD NOZZLE

ID: 7557

Corrosion on 50 year old inlet manifold at bottom of 80 metre deep column in ilmenite factory lead to a critical leak on one of the nozzles.

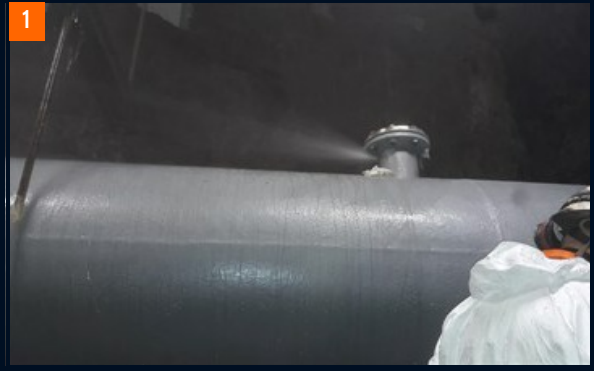
Due to severe corrosion a critical leak occurred while preparing the surface of the pipe externals. The surface is constantly moist and condensing, this made drying of the application surface very challenging.

1. Leak shown from the nozzle.
2. Closeup of leak area.
3. Leak stopped using 9611/1221.
4. Belzona 1212 wrap installed.

Application was carried out in accordance with a modified version of Belzona Know How System Leaflet VPF-11. Belzona 9611 and Belzona 1221 were used to successfully stop the leak within minutes. This was followed by an application of a composite wrap using Belzona 1212 to seal the area.
