# BELZONA PROTECTS OFFSHORE DEOILER/BIOCIDE TANK UNIT

ID: 7559

Internal coating of deoiler/biocide tank unit on an offshore FPSO

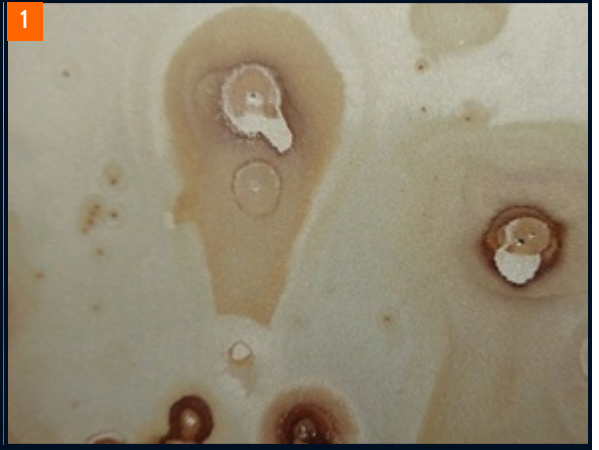
Pitting corrosion in an internal stainless steel tank, due to unprotected surfaces and hazardous chemicals. Weld particles also a possible explanation to the problems.

1. Pitted area.
2. Gritblast details.
3. Belzona 1311 applied to pitted areas.
4. Belzona 1381 completed application.

Application was carried out in accordance with Belzona Know-How System Leaflet SOS-2. Following gritblasting, Belzona 1311 was used to fill all pitted areas, mostly in the tank bottom. All tank surfaces were then coated in Belzona 1381.
