# BELZONA PROTECTS INCINERATOR EXHAUST DUCT

ID: 7560

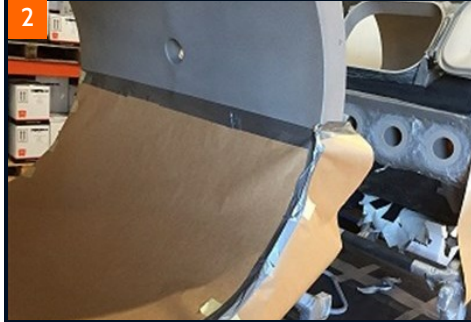
1. Units overview.
2. Gritblasting details and application preparation.
3. Coating application details.
4. Completed application ready for transport.

Application was carried out in accordance with Belzona System Leaflet VPF-2. Following gritblasting all internal surfaces of the 2 chimney units were coated with Belzona 1591.
