# BELZONA REPAIRS TURBINE EXHAUST MANIFOLD

ID: 7561

Exhaust manifold piping.

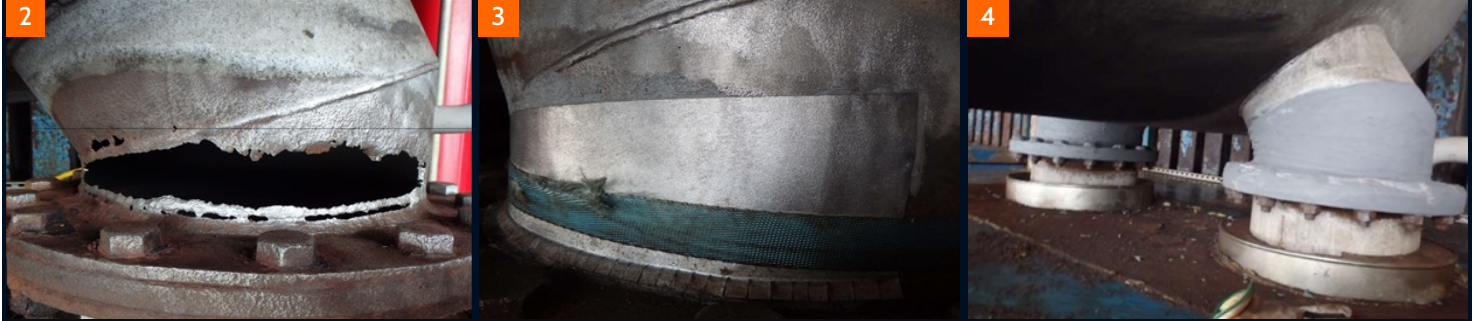
Due to severe corrosion these pipes were leaking exhaust gases in an area close to personell gangways creating a safety hazard. Temperatures in the area reached 200 C.

1. View of corroded area with through wall defect.
2. Surface preparation carried out.
3. Metal plate bonded in position
4. Completed application

Application was carried out in accordance with Belzona System Leaflet VPF-11. A thin plate was bonded to cover the defect area and to prevent ingress of product during application. Two consecutive layers of Belzona 1511 HT Metal reinforced with Belzona 9341 were applied leaving a solid composite wrap of 20mm thickness.
