# BELZONA PROTECTS RIVER BACK-FLOW VALVES

ID: 7563

River backflow valves at a water treatment plant.

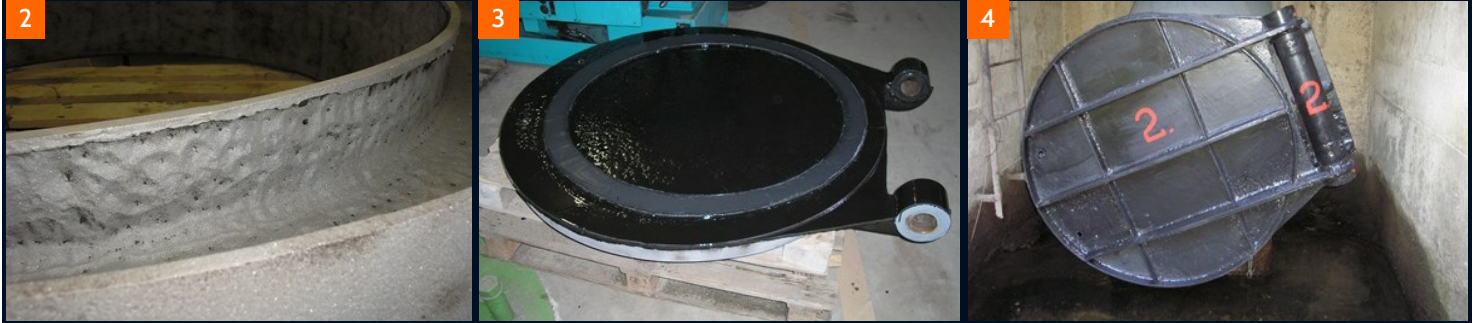
The valves suffered from erosion and corrosion through continued use. The valve was so badly damaged that it leaked even when shut.

1. Leaking back-flow valve before reconstruction.
2. Valve after blasting.
3. Shut off flap coated with Belzona 5811 and Belzona 2211.
4. Valve back in operation.

A Belzona repair avoiding costly repairs or replacement. This repair got the valve back in operation faster than traditional methods and with minimal disruption to the plant operation.

Belzona 1111 (Super Metal)  
Belzona 5811 (Immersion Grade)  
Belzona 2211 (MP Fluid Elastomer)
