# BELZONA REPAIRS CONCRETE FOOTING

ID: 7564

The concrete footing of a cutting machine in a large workshop.

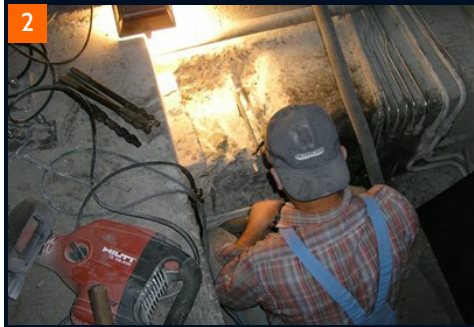
The footing was damaged by impact, this caused instability on the machine which meant it could not be used.

1. Destroyed concrete footing.
2. Belzona 4911 (TX Conditioner) application
3. Repair in progress
4. Belzona 4111 used to rebuild the base
