# BELZONA KEEPS THE COVER ON ANNEALING OVEN

ID: 7566

Large annealing oven at a metal manufacturing plant.

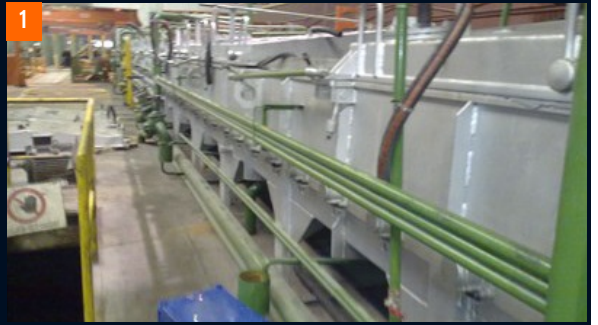
The cover had distorted and did not sit correctly on the base and caused a CO2 leakage.

1. Annealing ovens
2. Surface preparation
3. Belzona 1121 application
4. Cover replaced
