# BELZONA REPAIRS A CAR ENGINE CASING

ID: 7567

Cracked Engine Casing on a government vehicle.

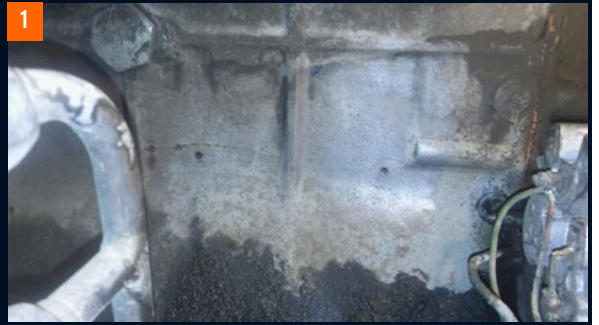
The freezing winter temperatures had caused excessive movement and a crack in the engine casing.

1. Cracked engine.
2. Crack detection.
3. Surface preparation.
4. Belzona 1111 application with reinforcement tape.
