# BELZONA REPAIRS PIN BUSH HOUSING

Pin Bush Housing on mining power shovel.

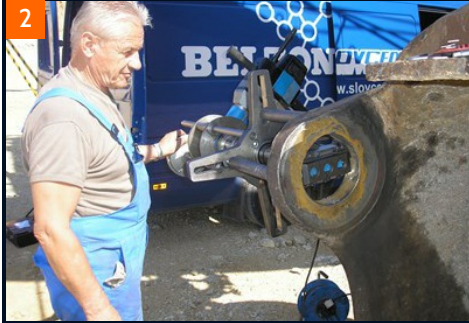
1. Mining Power Shovel.
2. Machining to proper diameter for Belzona 1111 application.
3. Bushing inserted.
4. Ready for service.

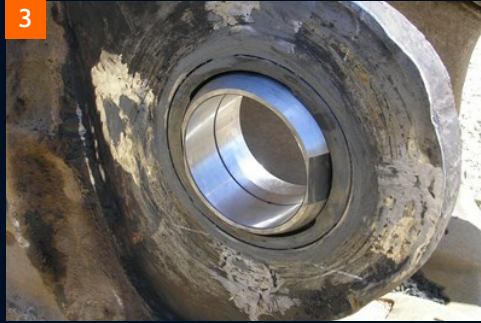
Housing had been damaged and worn down over time.

Application was carried out in accordance with Belzona Know-How System Leaflet MPT - 08.
