# BELZONA PROTECTS MIXING TANK

ID: 757

## PROBLEM

Customer needed protection on their KMnO<sub>4</sub> (Potassium Permanganate) mixing tank.

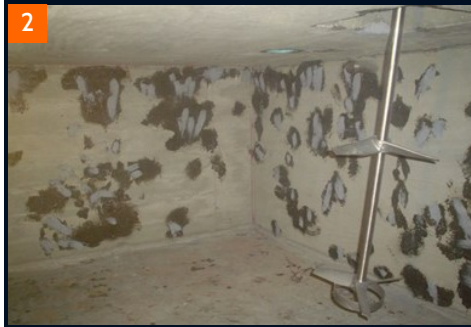
1. Bare unprotected mixing tank.
2. Surface prepared and holes patched with Belzona 4111.
3. First coat Belzona 5811 being applied.
4. Final coat Belzona 5811 applied.
