# BELZONA PROTECTS AGAINST EROSIVE MILLED CORN

ID: 7571

Pneumatic pipe system for transporting milled corn.

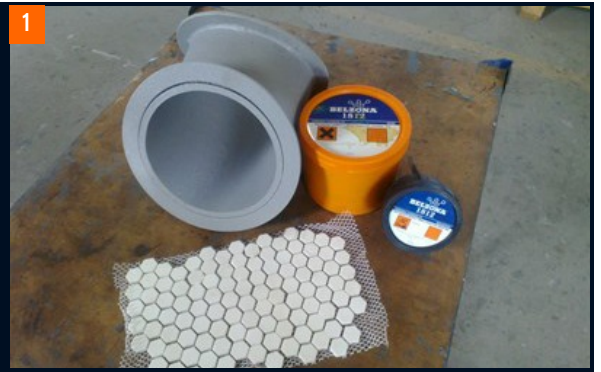
The pipe was suffering from heavy abrasion from the milled corn.

1. Ready for repair.
2. Belzona 1812 application.
3. Belzona 9811 application.
4. Ready for work.

Application was carried out in accordance with Belzona System Leaflet SHM-7.
