# BELZONA PROVIDES HIGH TEMPERATURE CHEMICAL PROTECTION

ID: 7572

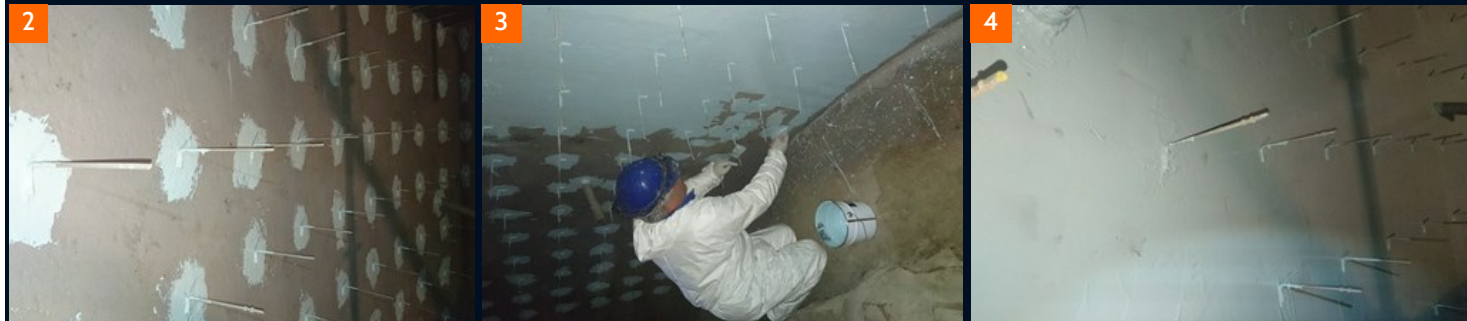
The critical issue stemmed from acidic formation on the steel spikes as the furnace cooled down, leading to the spikes corroding away, and in turn, the insulation falling off making the furnace inefficient.

1. Corroded and damaged surface.
2. In addition to the wall, the peaks also had to be protected.
3. The first layer of Belzona 1593 product.
4. The second layer of Belzona 1593 product.

The application was carried out in accordance with Belzona Know-How System Leaflet TCC-5.
