# BELZONA REPAIRS MANWAY FLANGE ON RAILWAY TANK

ID: 7574

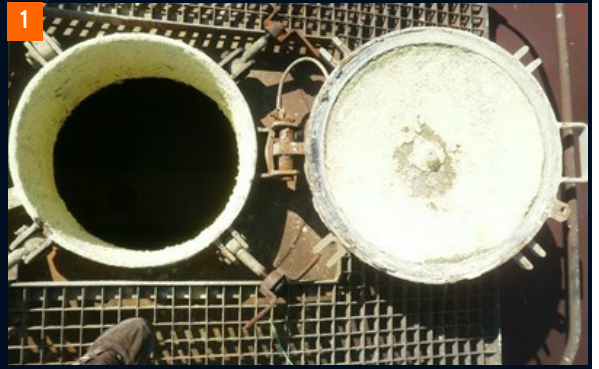
This tank was used to carry sulphuric acid, however, the manway area was not suitably protected so suffered from corrosion damage.

1. Damaged manway
2. Following grit blasting
3. Completed Application
4. Alternate view

Welding of a replacement flange was not an option for the customer. A rebuild and coat with Belzona solved the issue in a fraction of the time and cost, also preventing further damage from sulphuric acid.
