# BELZONA REPAIRS AND RESTORES PUMP

ID: 7575

Erosion and Corrosion damage

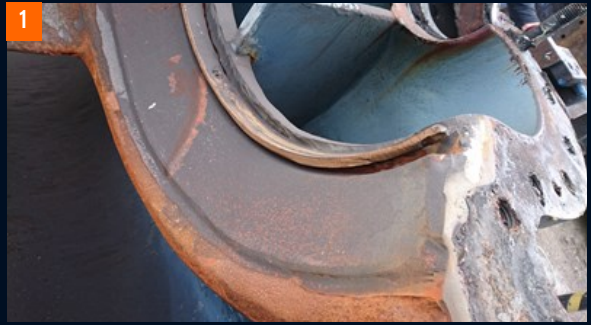
This was a complete overhaul of the pump. Several years of operation (cooling water with small steel particles) resulted in a damaged stator, rotor and bearings.

1. Destroyed stator.
2. Pump grit blasted.
3. Pump casing after reconstruction.
4. Ready for service.
