# BELZONA REPAIRS BROKEN RBC BASE

Concrete base for gearbox on the RBC (Rotating Biological Collector).

Waste Water Treatment Plant in Oklahoma

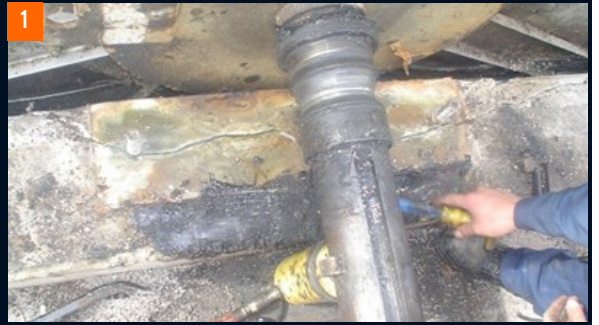
While replacing the gearbox the customer broke the concrete base and anchors.

1. Broken base
2. Area prepared & conditioned, backboard in place, anchors aligned, and filling with Belzona 4111
3. Base filled with Belzona 4111.
4. Completed repair back in operation.
