# BELZONA PROTECTS A NEW CONDENSER

ID: 7581

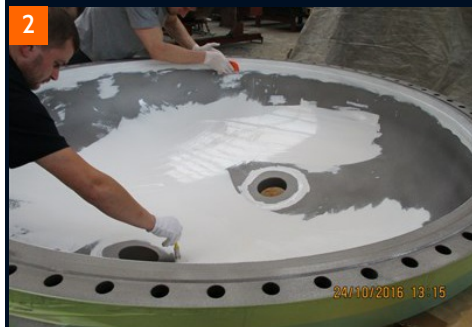
1. Condenser after grit blasting.
2. Applying Belzona 5892 on the condenser cover.
3. Completed application.
4. Condenser after application.

Application was carried out in accordance with Belzona System Leaflet HEX-03. After preparing the surface by grit blasting, a stripe coat was applied on complex areas such as edges, welds etc. Then 2 coats of Belzona 5892 were applied.
