# BELZONA REPAIRS AND PROTECTS PUMP VOLUTE IN NUCLEAR PLANT

ID: 7582

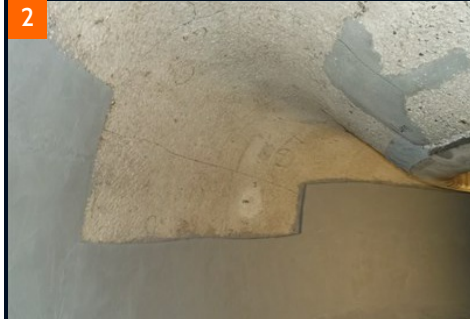
1. Surface preparation.
2. Application of Belzona 4111 in progress to rebuild the concrete wall.
3. Final coat of Belzona 1321.
4. Finished application.

The application was carried out in accordance with Belzona Know-How System Leaflet CEP-03. Belzona 4111 and Belzona 1321 were used to repair and protect the walls.
