# BELZONA REPAIRS CORRODED PUMP CASING

ID: 7583

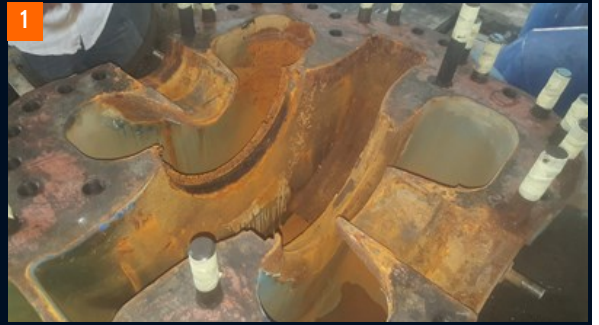
The pump had suffered extensive corrosion.

1. Corroded pump casing.
2. After grit blasting.
3. Application of Belzona 1311.
4. Application complete.
