# CONCRETE BUND RESTORED

ID: 7588

Concrete bund on a chemical site for catching 98% Sulphuric Acid spills

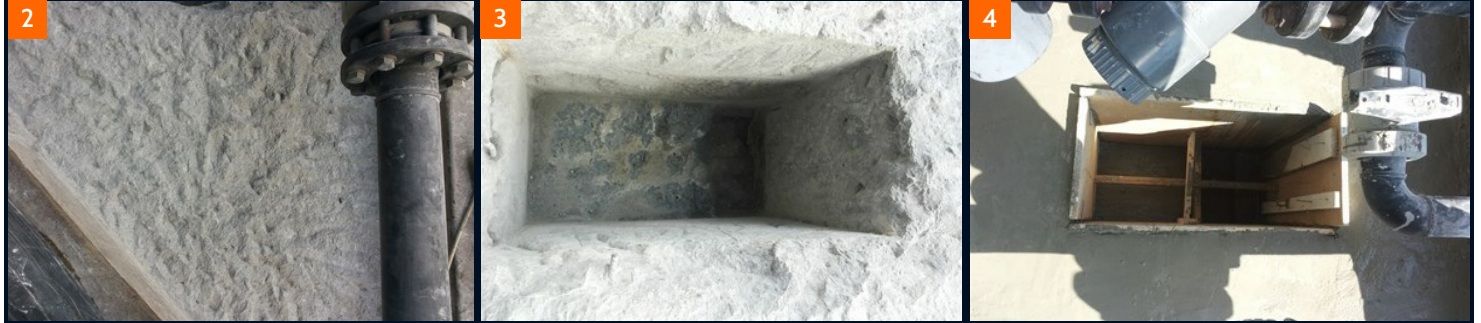
The acid attack had severely damaged the concrete over time, this lead to the acid not being

1. Damaged concrete basement
2. Surface preparation
3. It was necessary to prepare firm surface
4. After Belzona application

Application was carried out in accordance with Belzona Know-How System Leaflet TCC-15.

Belzona 4301 (Magma CR1 Hi-Build)  
Belzona 4311 (Magma CR1)
