# BELZONA REPAIRS RBC SHAFT

ID: 759

RBC (Rotating Biological Contactor) shaft.

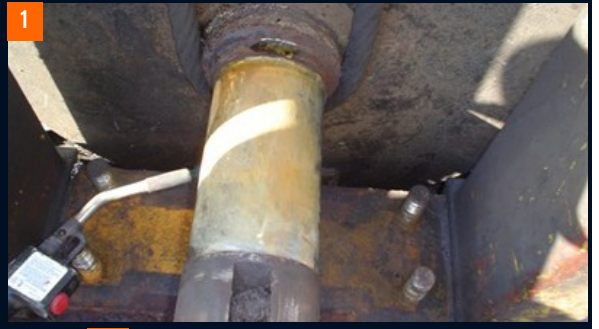
The bearing failed, damaging the shaft.

1. Damaged shaft
2. Shaft prepared and ready for Belzona
3. After curing former removed and extrusions filed down
4. The RBC is resealed and back in service
