# BELZONA PROTECTS FRANCIS TURBINE RUNNER

ID: 7591

Francis Turbine Runner was suffered extensive damage.

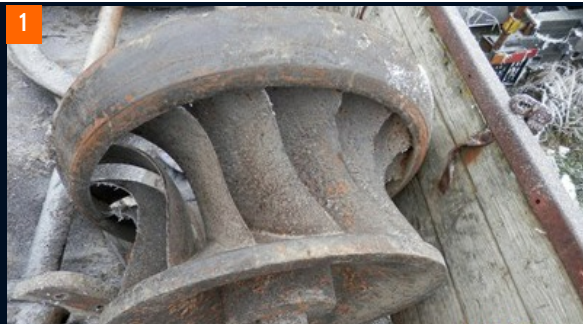
Erosion/Corrosion

1. Turbine in very bad condition
2. Repair in progress
3. Repair in progress
4. Turbine like new
