# BED PLATE OF PRESSING MACHINE REBUILT WITH BELZONA

ID: 7594

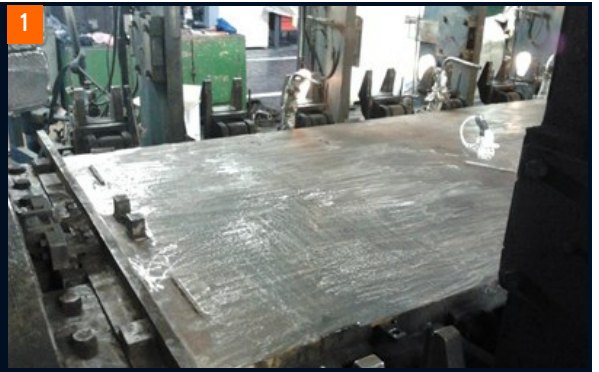
Hydrochloric acid condensed from the process destroyed the base plate of the pressing machine.

1. Surface preparation
2. Belzona 1111 being applied
3. The plate ready for leveling by grinding

Application was carried out in accordance with Belzona Know-How System Leaflet ENC-7. After Belzona 1111 application it was necessary to level the plate by grinding.
