# BELZONA REPAIRS BLOWER WHEEL

ID: 7595

Blower used in pneumatic sorting of cement.

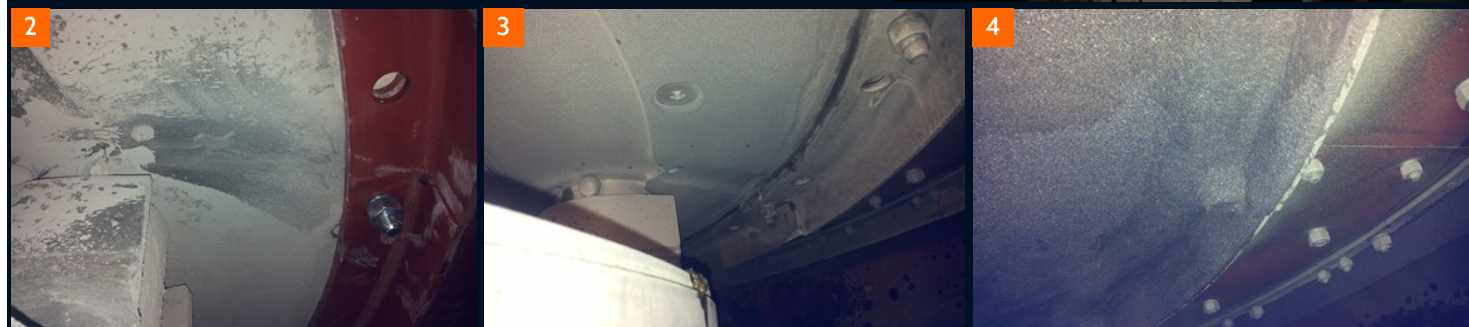
## PHOTOS

Where the cement hits some areas of the blower they experienced severe abrasion and erosion. They required an alternative to welding fresh metal plates to reinstate lost material.

1. Blower.
2. Damaged areas.
3. After grit blasting.
4. Belzona 1811 application.

In some cases it was not possible to weld new plates as substrate was too thin and in difficult to reach areas. Belzona protection was a faster and more effective solution. It is also easier to maintain in future.

Belzona 1811 (Ceramic Carbide)  
Belzona 1812 (Ceramic Carbide FP)
