# BELZONA REPAIRS AIR PIPE DISTRIBUTOR

ID: 7596

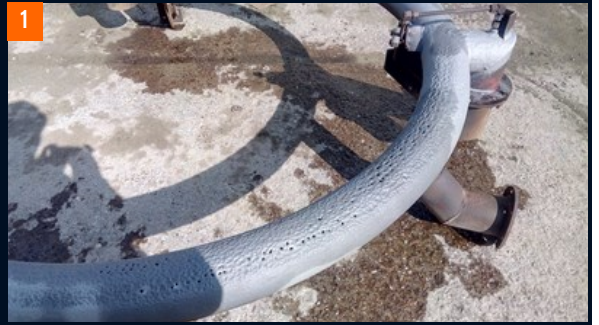
Whilst the system was offline, condensed gases created corrosion (deep 3 mm) on the DN 125 air pipe distributor.

1. Air distributor after blasting.
2. Belzona 1111 plus reinforcement tape.
3. Full extent of the pipe.
4. Belzona application complete.

Application was carried out in accordance with Belzona Know-How System Leaflet VPF - 11.
