# BELZONA REPAIRS MOULD FLANGE

ID: 7597

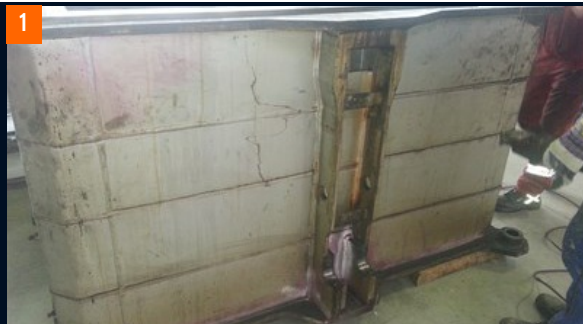
During mould manipulation workers damaged the flange leading to loss of critical dimension.

1. Mould has massive construction
2. Surface preparation
3. Belzona 1111 application
4. Final grinding to achieve correct level

Because the mould has massive construction it was not possible to bend sealing face back. Welding would have taken a long time. Repair with Belzona 1111 was done very quickly.
