# CORROSION OF THE STEEL CONSTRUCTION

ID: 7598

Corrosion to the steel frame work following exposure to chemicals

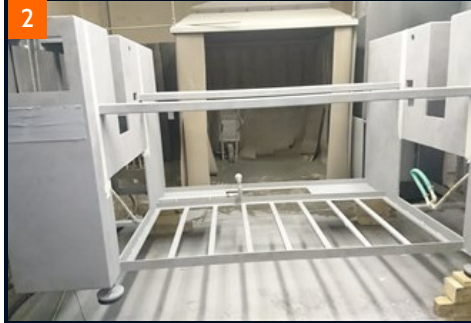
Customer uses this steel construction like a part of the degreasing line in the surface treatment hall with chemicals caused damaging.

1. Technical chemicals caused damaging
2. Construction after blasting
3. Coating selected impacted areas by Belzona 5811
4. Given that the customer finds Belzona 5811 suitable for this application, he repeats other constructions at regular intervals (image from 2016 order).
