# BELZONA PUMP SEATING REPAIR

ID: 7600

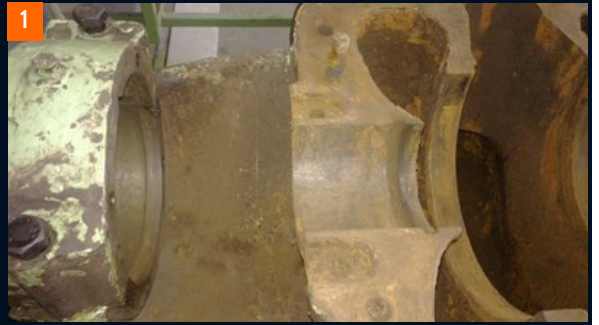
Corrosion, mechanical damage

After long time operation the pump has worn down seating. Result is a big clearance of the bearing.

1. Damaged pump seating
2. Machining of the Belzona 1111
3. Ready for customer
