# BELZONA REPAIR THE WELDING ALUMINUM SEAMS

ID: 7601

Slovakia, heating plant

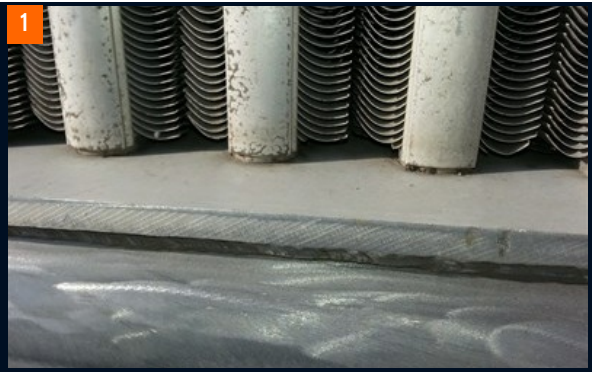
Cracks in the aluminium

Vacuum condenser has aluminium construction. Source of the cracks on the welding seams is mechanical movement from temperature differences.

1. Damaged vacuum condenser
2. Blasting
3. Belzona 2211 application
4. After Belzona 2131 application
