# REPAIRING POWER STATION COOLING WATER PUMPS WITH BELZONA

ID: 7602

Main cooling water pump.

Power station, Slovakia

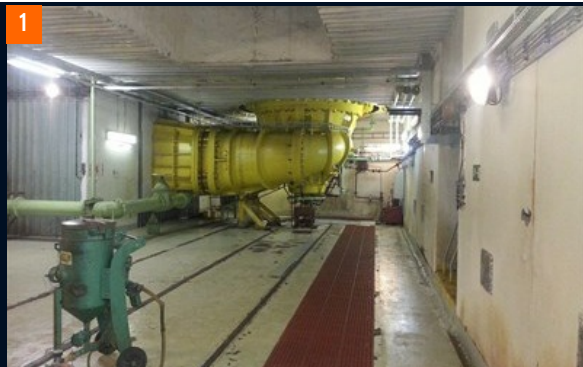
1. TG pump

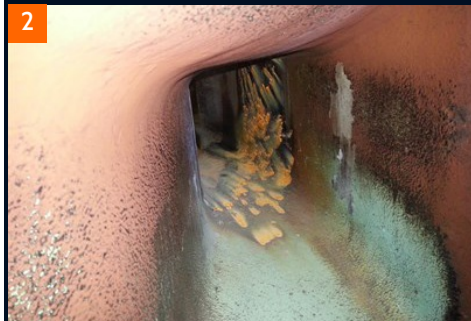
This pump had been in service for 35 years and was suffering erosion corrosion damage due to constant water flow.

2. Damaged area

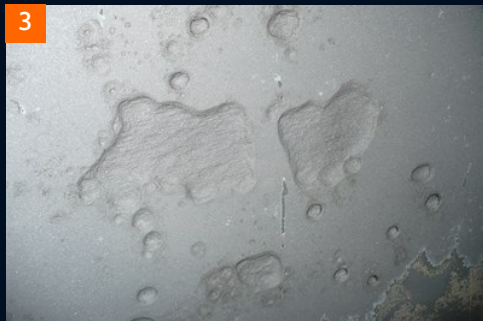
3. After blasting

Application was carried out in accordance with Belzona Know-How System Leaflet CEP - 3 and CEP - 5

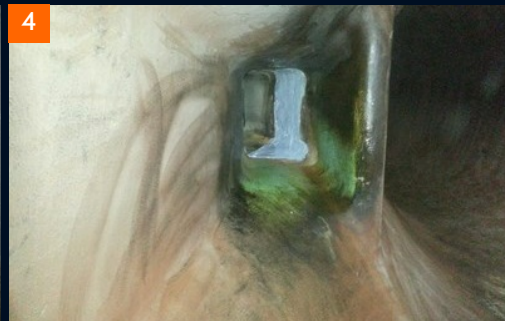
4. After Belzona 1311 and Belzona 1341 application.

Belzona 1311 (Ceramic R Metal)

Belzona 1341 (Supermetalgilde)
