# PLATE HEAT EXCHANGERS REPAIRED WITH BELZONA

ID: 7603

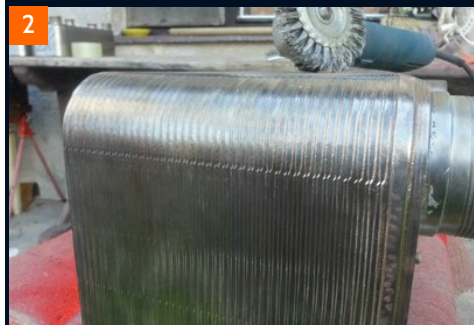
After 8 years operation some leaks appeared due to corrosion.

1. Damaged exchanger
2. Surface preparation completed using an MBX Bristle Blaster
3. Belzona 1212 and reinforcement tape applied
4. Ready for operation
