# PUMP REPAIR WITH BELZONA

ID: 7604

Cellulose production plant, Slovakia

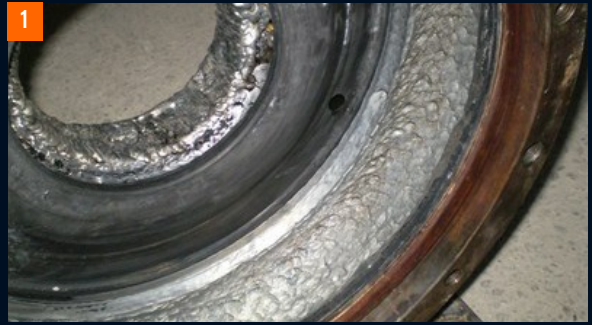
Corrosion and erosion from chemicals (caustification plus  $\text{CaCO}_3$  and  $\text{CaO}$ )

Pump erosion and corrosion every 6 months

1. Damaged pump
2. After blasting
3. Belzona 1311 application
4. Belzona 1391 application
