# VACUUM DRUM PIVOTS REPAIRED WITH BELZONA

ID: 7605

vacuum drying drum used in cellulose production

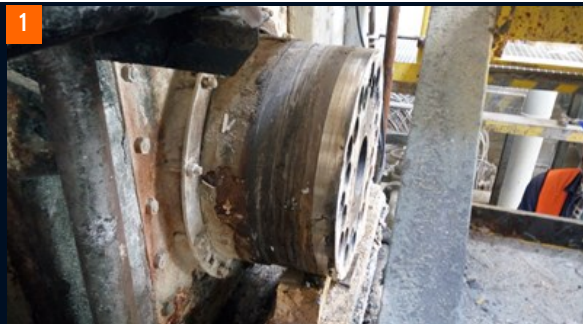
After long time in service the pivot/shaft had become badly worn aggravated by corrosion.

1. Damaged pivot
2. Cleaning and preparing
3. Belzona 1111 after application
4. Belzona 1111 (after 3 years and bronze break down) still on the place.

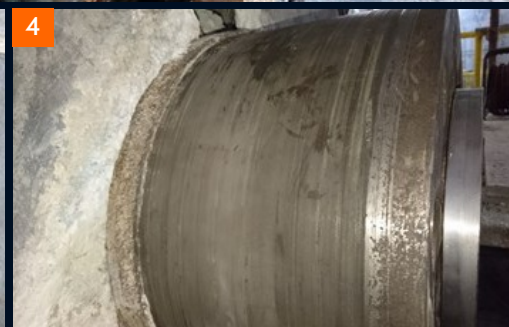
Welding would have taken a long time with risk of the bending/structural distortion. Belzona solution is corrosion resistant and quickly and accurately restored original dimensions. In the year 2019, after 3 years production, company needed to repair it. This is a sliding bearing with bronze seating. They acknowledged a mistake; they forgot about lubrication for some time... When we arrived to see it, Belzona 1111 was still in place, but not bronze seating. It was enough to apply a thin layer of Belzona 1111 and change the bronze bearing.
