# SLIDE ASSEMBLY WITH BELZONA REPAIR

ID: 7606

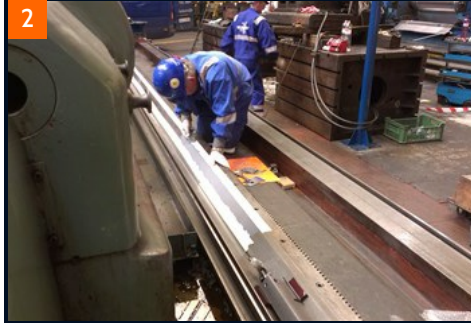
Corrosion accelerated due to the inclusion of water and chemicals within the process

Slide assembly were damaged from corrosion.

1. Damaged slide assembly
2. Belzona 1311 application
3. All surface were sanded down
4. Support ready to work
