# BELZONA REFURBISHES BRAKE TEST ROLLERS

ID: 7609

Brake test rollers at vehicle testing station.

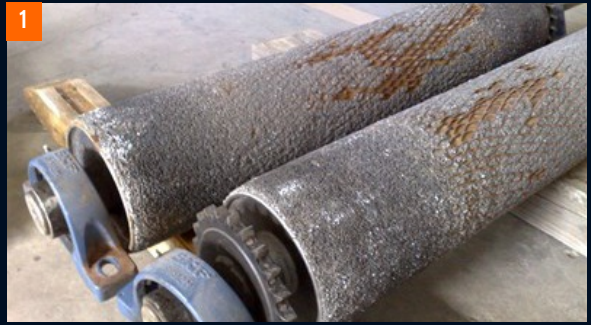
After many thousand tests the surface of the rollers required a new non-slip surface applying.

1. Damaged rollers
2. Belzona 9211 Supergrip Aggregate application into Belzona 1821
3. Ready to work
