# COOLING TOWER COATED WITH BELZONA 5811 BY SPRAY

ID: 761

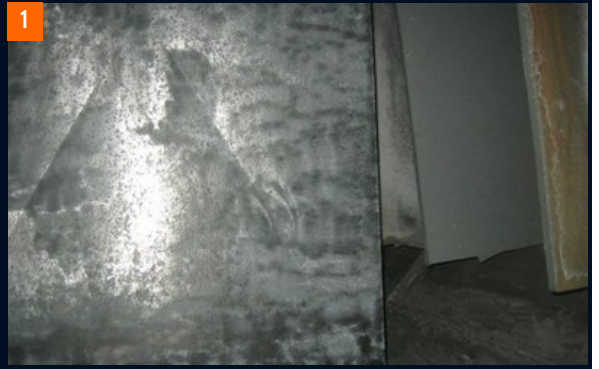
Previous coating was coming off before going into service.

1. Previous coating easily blasted off.
2. Application Pump made ready.
3. Material spray applied to 700 square feet very quickly.
4. Door closures were also coated and job completed.
