# BELZONA PROVIDES A SLIDING SURFACE REPAIR ON SEALING RINGS

ID: 7610

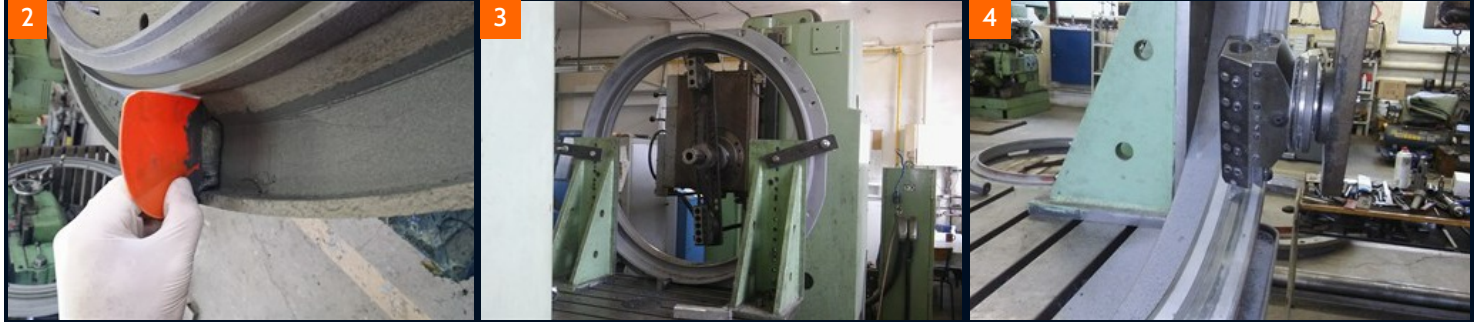
Erosion, corrosion

Sliding surfaces of sealing rings were worn down from rubber sealing.

1. Damaged surface
2. Belzona 1311 application
3. Machining of Belzona 1311 for right diameter
4. Machining of Belzona 1311 for right diameter

Application was carried out in accordance with modified Belzona Know-How System Leaflet CEP - 02

Rings are too thin for welding and replacing is very expensive.
